**CITY OF BETHEL  
PORT COMMISSION**

## STRUCTURAL CONDITION ASSESSMENT

This report describes engineering services for the condition assessment of the Port of Bethel steel sheet pile bulkhead and the steel/timber east wingwall. The primary purpose of the visual inspection was to evaluate the structure's overall condition, determine the significance of observed damage and deterioration, identify necessary future inspections and maintenance, determine maintenance priorities, and address the immediate and long-term corrective actions. The inspection provides a snapshot evaluation at the time of inspection.

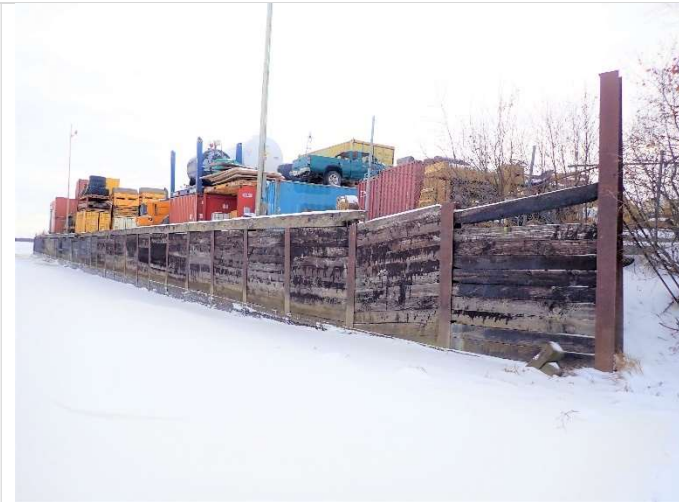
Pile jacking at north end of the timber wall

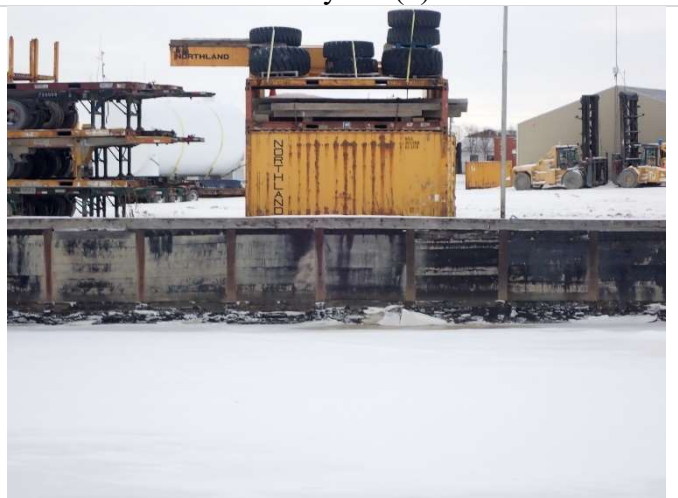
Differential settlement or jacking along timber wall

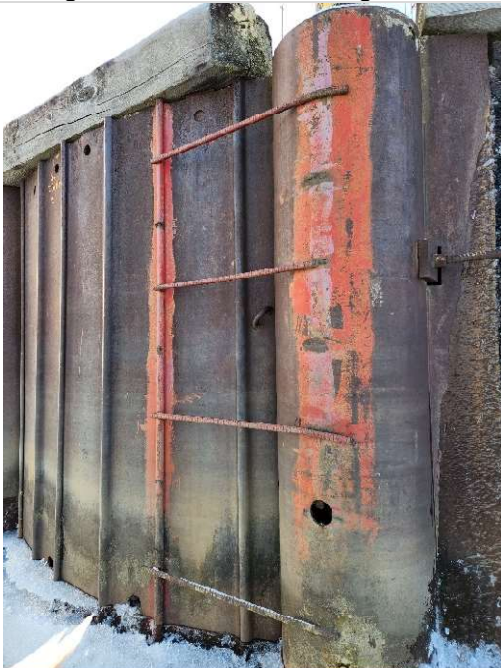
- Safety ladders are located at each of the 6 mooring bollards which are spaced roughly 80' apart. Some of the rebar rungs are damaged and missing and do not provide safe egress from the water. These ladders do not meet safety code.

Damaged safety ladder at soldier pile T35 & S1

- Retrofit the east wing wall to stiffen the connection to the closed cell sheet pile.
- Remove the existing, deficient safety ladders. Provide new safety ladders at 100' intervals along the face of the bulkhead.
- Provide life rings at 200' intervals along the face of the work area.

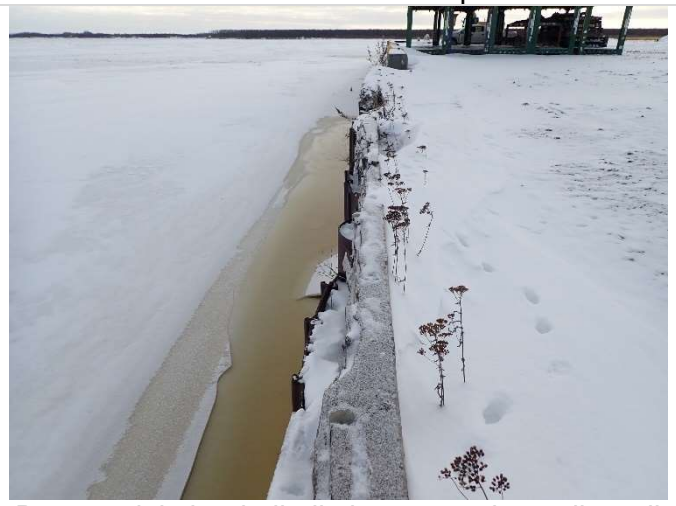
Damaged timber bullrail along east sheet pile wall

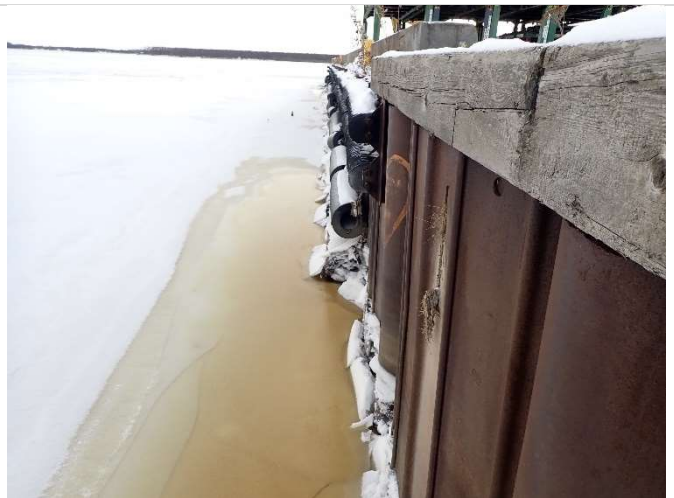
Damaged sheet pile on east wall

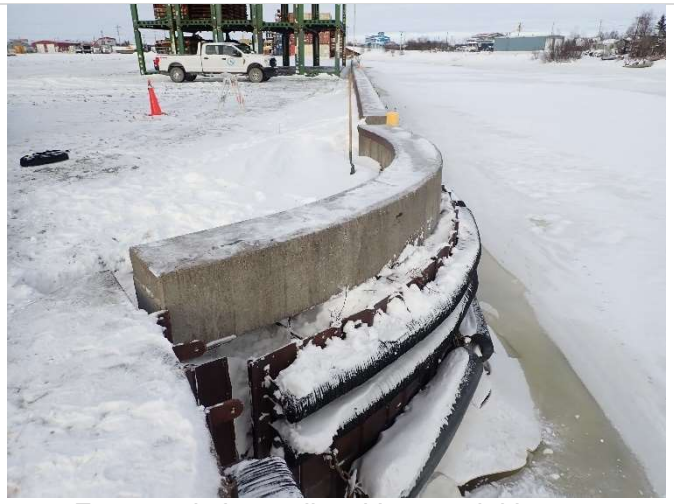
The east wingwall has a fractured sheet pile near the connection with the closed cell of the main dock structure. The damaged sheet pile has been cut perpendicular to the crack and through the interlock and web of the adjacent sheet. The horizontal cut line follows a failed weld that appears to have spliced the top five feet of sheet pile wall to a lower section. The metal between the two sections appears to have different ages or material properties with the top section exhibiting more signs of corrosion than the lower section. The horizontal cut is roughly 63" below the top of wall.

The sheet pile fracture in the east wing wall likely occurred due to the connection between a flexible, cantilevered sheet pile wall and a rigid closed cell structure. The dock's closed cell structure is a very rigid system that gains its strength and stability from the shear strength and uses the weight of the contained infill material to resist applied loads. The attached east wingwall, on the other hand, is a flexible system that relies on tiebacks extending shoreward from the soldier piles and connected to anchor walls to utilize the lateral pressure of the wall backfill to anchor the system. The t-pile connection between the two systems creates a large stress concentration and fatigue loading on the wing wall and caused it to respond like a paperclip being flexed back and forth too many times with the load cycles.

Fractured sheet pile with material loss at connection between east wing wall and dock closed sheet pile dock cell

Fractured sheet pile with material loss at east wing wall

The damaged east wing wall section should be repaired or rehabilitated. To rehabilitate the wall section to the original, as-designed capacity, the damaged sheet pile should be removed and replaced with new. Because the existing PS28 sheet is no longer produced, a new sheet could be fabricated from a PS31 sheet pile to match the existing interlock width of 15 inches. A sample PS31 sheet was sent to Ed Flores at the City of Bethel to confirm that the interlock is compatible with existing. This distance between interlocks at the damaged section may have increased due to wall creep, and the existing flat sheet piles will not have much stretch to allow the gap to be closed. One potential option would be to have two halves of the replacement sheet be field welded along the web to field-fit the replacement.

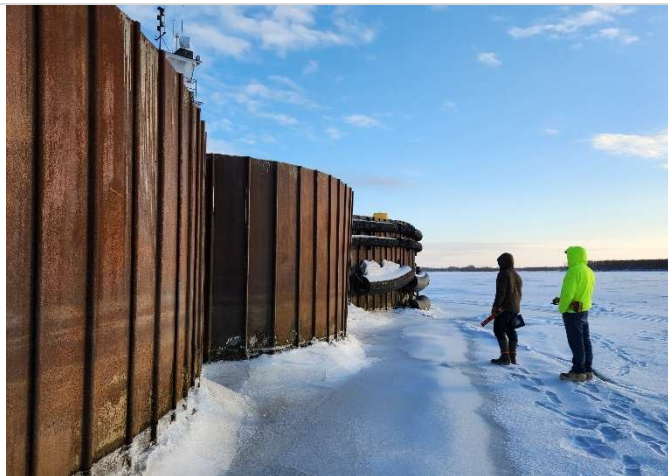
- The closure wall between the closed sheet pile cell, CC4, and the open sheet pile cell, OC1, has a tilt angle close to plumb at the t-pile connections to the cells but leans seaward by four degrees at the middle of the closure wall. This generates strong concern about risk of web fracturing similar to the east wingwall and portions of the east wall near soldier piles S11 – S13 and should be closely monitored for crack development.

Leaning closure wall between closed cell, CC4, and open cell, OC1. Photo taken in Dec inspection when the ice was thick enough for foot traffic along the east and west walls.

The east wall should be closely monitored for additional crack formation in the sheet pile webbing, and the west wing wall should be monitored to determine if the seaward tilt is increasing and to monitor for crack development in the sheet pile webbing.
