# CITY OF BETHEL

## PORT COMMISSION

## STRUCTURAL CONDITION ASSESSMENT

The following report describes engineering services related to the above-water condition assessment of the Port of Bethel steel and timber bulkhead (wall). The site was inspected on November 3, 2022, by Nate Geary, a structural design engineer from DOWL's Bridge and Structures section; and the face of the wall was inspected on December 7, 2022, by Chase Nelson, a senior engineer with DOWL. Mudline elevations were measured along the perimeter of the wall on June 14, 2023. The weather was 10 degrees Fahrenheit with winds at 10-15 mph and blowing snow during the initial inspection. The site was hit with a winter storm two days prior to the initial inspection resulting in snow on the site and a mostly frozen river preventing skiff access along the face of the wall. The primary purpose of the routine inspection was to:

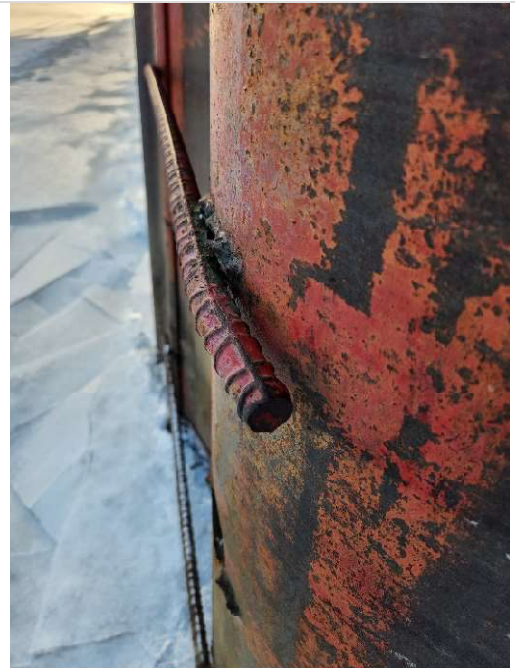
- Safety ladders are located at each of the 6 mooring bollards which are spaced roughly 80' apart. Some of the rebar rungs are damaged and missing and do not provide safe egress from the water. These ladders do not meet safety code.

Damaged safety ladder at soldier pile T35 & S1

- Retrofit the east wing wall to stiffen the connection to the closed cell sheet pile.
- Remove the existing, deficient safety ladders. Provide new safety ladders at 100' intervals along the face of the bulkhead.
- Provide life rings at 200' intervals along the face of the work area.

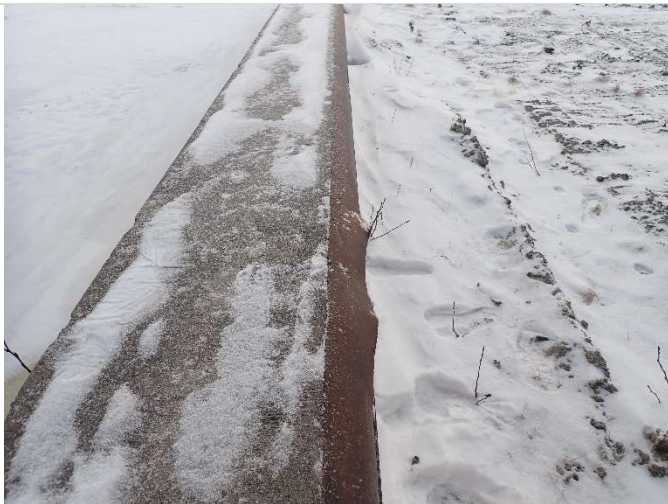
Minor damage to concrete curb metal strip along east wall.

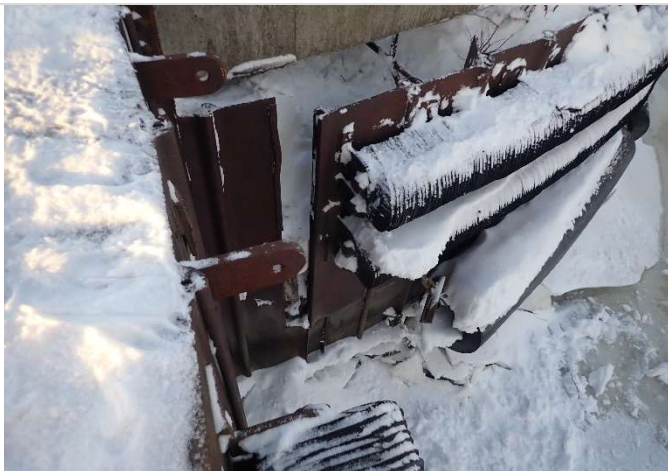
The sheet pile fracture in the east wing wall likely occurred due to the connection between a flexible, cantilevered sheet pile wall and a rigid closed cell structure. The dock's closed cell structure is a very rigid system that gains its strength and stability from the shear strength and uses the weight of the contained infill material to resist applied loads. The attached east wingwall, on the other hand, is a flexible system that relies on tiebacks extending shoreward from the soldier piles and connected to anchor walls to utilize the lateral pressure of the wall backfill to anchor the system. The t-pile connection between the two systems creates a large stress concentration and fatigue loading on the wing wall and caused it to respond like a paperclip being flexed back and forth too many times with the load cycles.

Fractured sheet pile with material loss at connection between east wing wall and dock closed sheet pile dock cell

Fractured sheet pile with material loss at east wing wall

The damaged east wing wall section should be repaired or rehabilitated. To rehabilitate the wall section to the original, as-designed capacity, the damaged sheet pile should be removed and replaced with new. Because the existing PS28 sheet is no longer produced, a new sheet could be fabricated from a PS31 sheet pile to match the existing interlock width of 15 inches. A sample PS31 sheet was sent to Ed Flores at the City of Bethel to confirm that the interlock is compatible with existing. This distance between interlocks at the damaged section may have increased due to wall creep, and the existing flat sheet piles will not have much stretch to allow the gap to be closed. One potential option would be to have two halves of the replacement sheet be field welded along the web to field-fit the replacement.

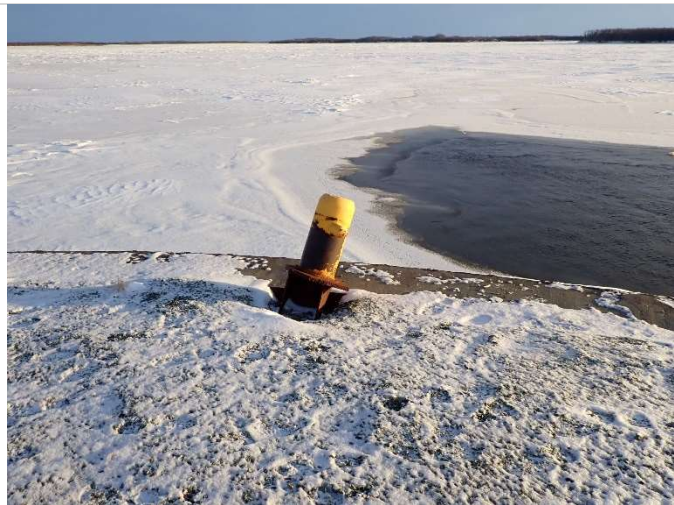
- A 10" diameter mooring bollard mounted on a HP pile is damaged and appears to have been overloaded.
- Two of the four 24" diameter pipe-pile mooring bollards are damaged.

Damaged 10" dia bollard at SE corner of dock (closed cell #1)

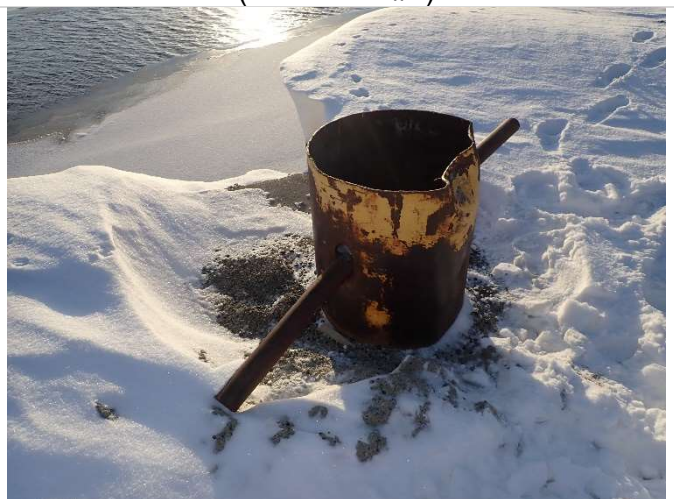
Damaged 24" dia pipe pile bollard at closed cell #3. Hole has been drilled through pile-pile with a 3" dia bar inserted through the pile

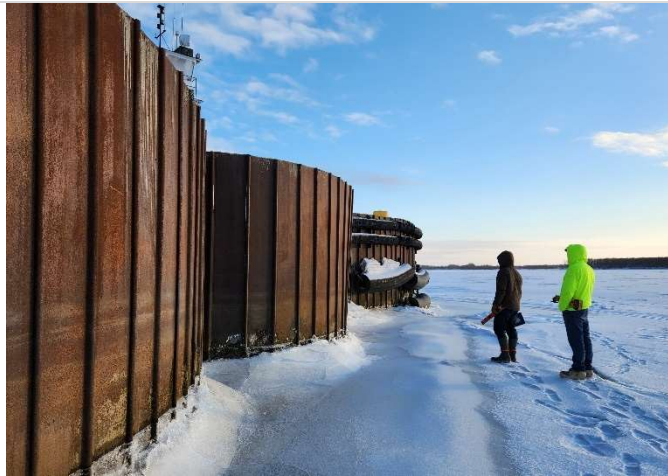
- The closure wall between the closed sheet pile cell, CC4, and the open sheet pile cell, OC1, has a tilt angle close to plumb at the t-pile connections to the cells but leans seaward by four degrees at the middle of the closure wall. This generates strong concern about risk of web fracturing similar to the east wingwall and portions of the east wall near soldier piles S11 – S13 and should be closely monitored for crack development.

Leaning closure wall between closed cell, CC4, and open cell, OC1. Photo taken in Dec inspection when the ice was thick enough for foot traffic along the east and west walls.

The east wall should be closely monitored for additional crack formation in the sheet pile webbing, and the west wing wall should be monitored to determine if the seaward tilt is increasing and to monitor for crack development in the sheet pile webbing.
