# CITY OF BETHEL

## City Council Meeting Agenda, October 14, 2024 – 6:00 PM

## STRUCTURAL CONDITION ASSESSMENT

# PORT WALL REPAIRS

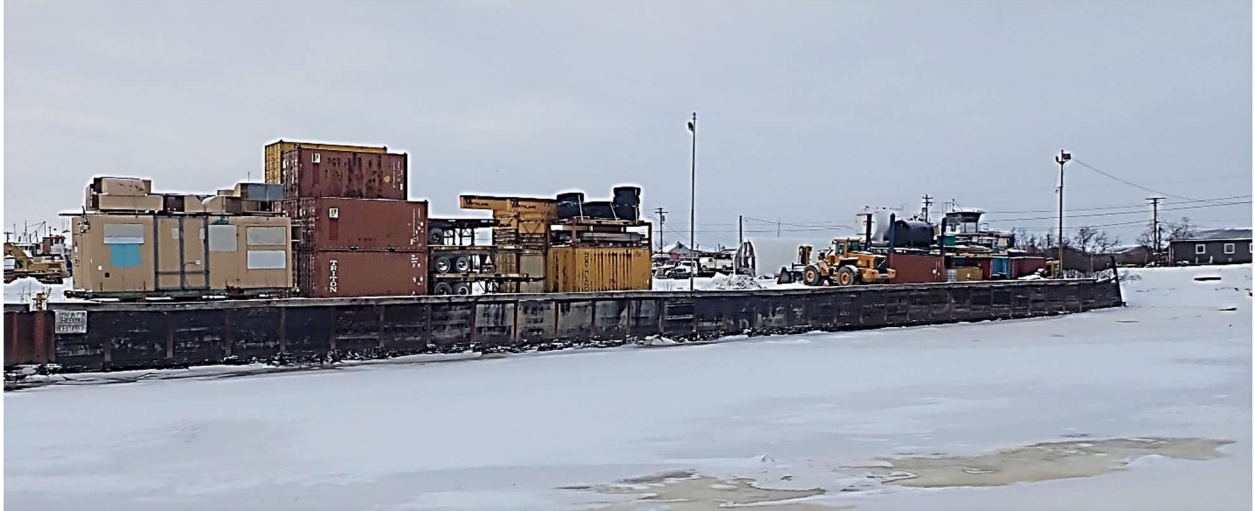
***Photo 1: East Wall – Timber Segment***

- The timber portion of the east retaining wall is highly permeable and built from driven HP piles with creosote treated retaining timbers that allow water seepage between the timbers. Spring breakup is likely the worst time for this condition where the water levels are high (near the top of the wall).

- The timber portion of the wall leans seaward toward Brown Slough by roughly two degrees with half of the wall leaning seaward by approximately five degrees, indicating multiple failed tiebacks.
- The steel HP and timber retaining wall material condition is fair.
- The 12x12 timber bullrail is missing a 16' section at the northern end of the wall. Overall, the timber bullrail is in poor condition with local failures and damage.
- Soldier pile, T17, is leaning seaward by 5.5 degrees; and the timber bullrail is damaged at the dap splice due to the wall movement.

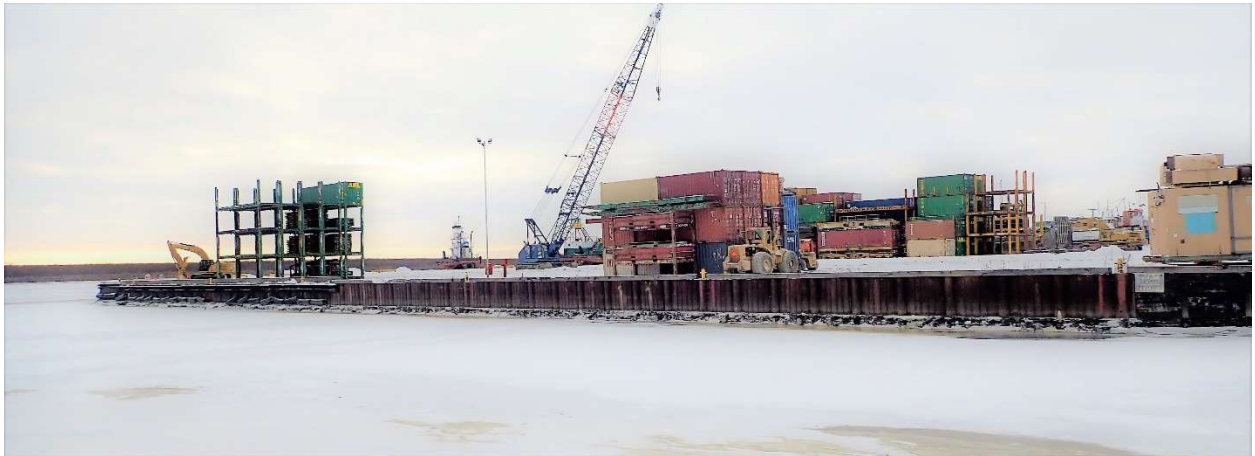
***Photo 2: East Wall – Sheet Pile Segment***

- Areas of the steel sheet pile has holes cut through the webbing between soldier piles S11 and S13. This corresponds with the segment of the wall leaning furthest seaward, and it appears the these were local failures with cuts made in the sheet pile webbing to arrest crack propagation.

- The sheet pile portion of the east wall has steel soldier pipe piles leaning seaward by an average of 0.5 degrees with roughly half the wall segment's piles leaning seaward by 2-3 degrees and indicating failed tiebacks.

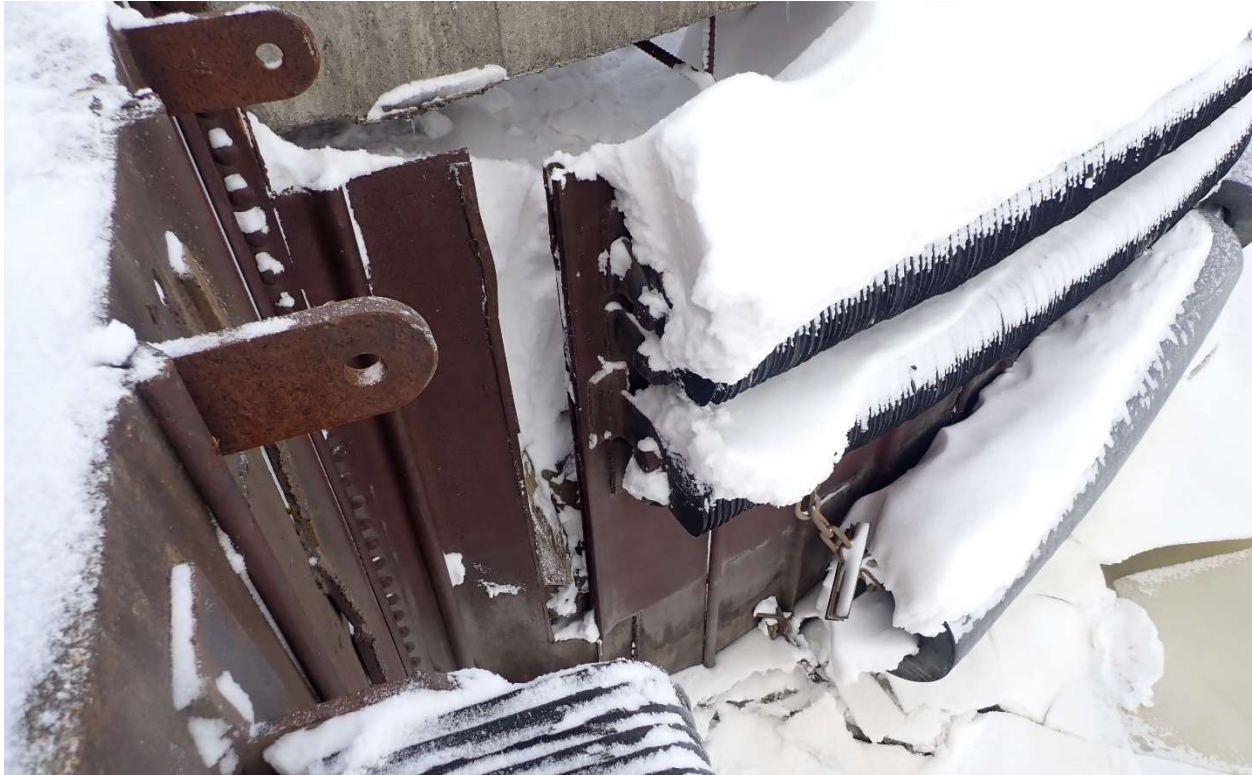
**Photo 4: Damaged East Wall Sheet Pile**

The east wingwall has a fractured sheet pile near the connection with the closed cell of the main dock structure. The damaged sheet pile has been cut perpendicular to the crack and through the interlock and web of the adjacent sheet. The horizontal cut line follows a failed weld that appears to have spliced the top five feet of sheet pile wall to a lower section. The metal between the two sections appears to have different ages or material properties with the top section exhibiting more signs of corrosion than the lower section. The horizontal cut is roughly 63" below the top of wall.

The wingwall has a soldier pile with a tie-back at the end furthest from the closed cell and has a riveted connection to a t-pile at the closed cell connection. The wall tilts seaward 1 degree at the soldier pile and is plumb at the closed sheet pile cell. The adjacent sheets tilt seaward with the largest value of three degrees tilt just below the damaged area. The mudline depth was measured at 13' below the top of wall (0' MLLW), and there is no toe undermining since the sheet piles are driven to elevation -28' MLLW.

The existing flat sheet piling used on the damaged wingwall section is no longer manufactured (PS28) and cannot be replaced in-kind.

The sheet pile fracture in the east wing wall likely occurred due to the connection between a flexible, cantilevered sheet pile wall and a rigid closed cell structure. The dock's closed cell structure is a very rigid system that gains its strength and stability from the shear strength and uses the weight of the contained infill material to resist applied loads. The attached east wingwall, on the other hand, is a flexible system that relies on tiebacks extending shoreward from the soldier piles and connected to anchor walls to utilize the lateral pressure of the wall backfill to anchor the system. The t-pile connection between the two systems creates a large stress concentration and fatigue loading on the wing wall and caused it to respond like a paperclip being flexed back and forth too many times with the load cycles.

The damaged east wing wall section should be repaired or rehabilitated. To rehabilitate the wall section to the original, as-designed capacity, the damaged sheet pile should be removed and replaced with new. Because the existing PS28 sheet is no longer produced, a new sheet could be fabricated from a PS31 sheet pile to match the existing interlock width of 15 inches. A sample PS31 sheet was sent to Ed Flores at the City of Bethel to confirm that the interlock is compatible with existing. This distance between interlocks at the damaged section may have increased due to wall creep, and the existing flat sheet piles will not have much stretch to allow the gap to be closed. One potential option would be to have two halves of the replacement sheet be field welded along the web to field-fit the replacement.

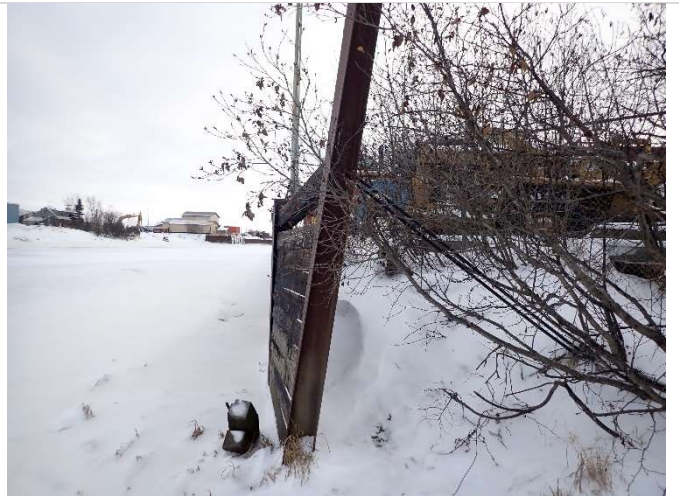
HP leaning shoreward as the pile frost jacks while still restrained by the (2) tie-backs

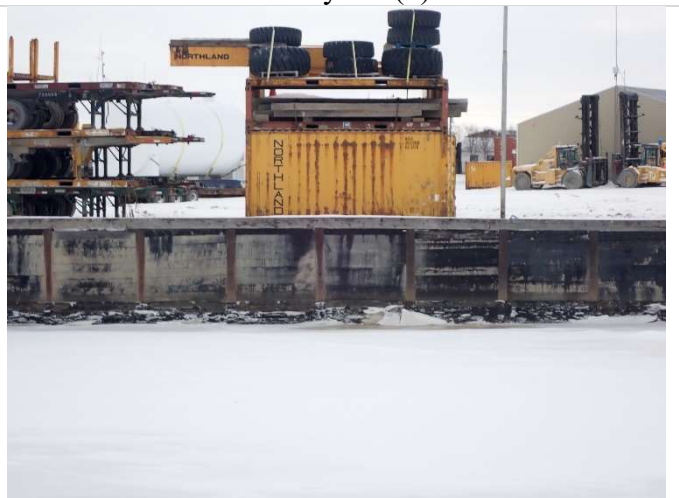
Differential settlement or jacking along timber wall

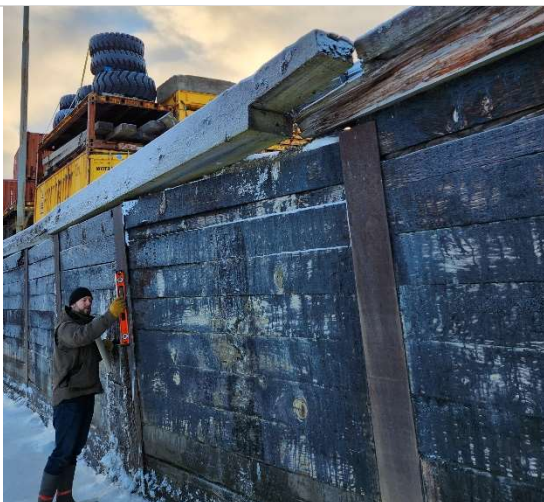
Evidence of failed tie-back along timber wall at soldier pile T17

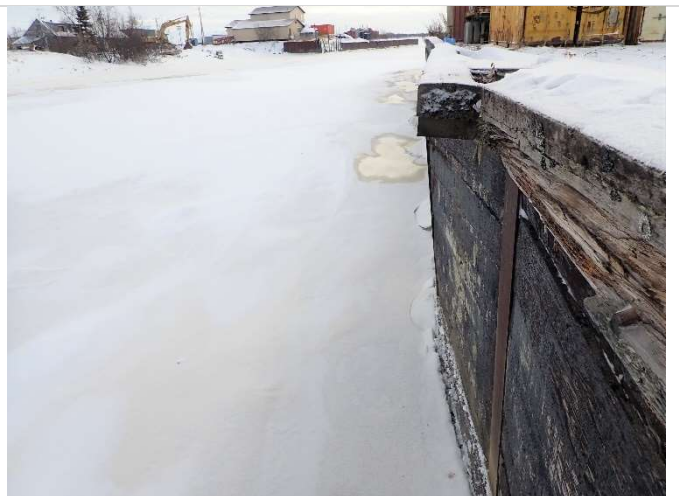
Evidence of failed tie-back along timber wall and damaged timber bullrail

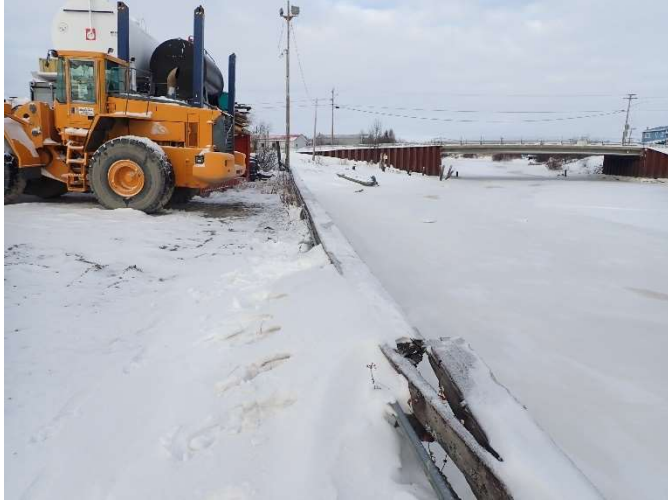
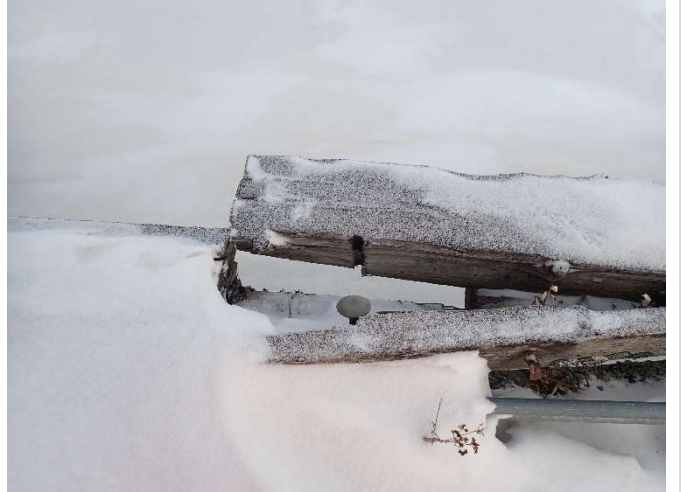
Damaged timber bullrail along timber wall

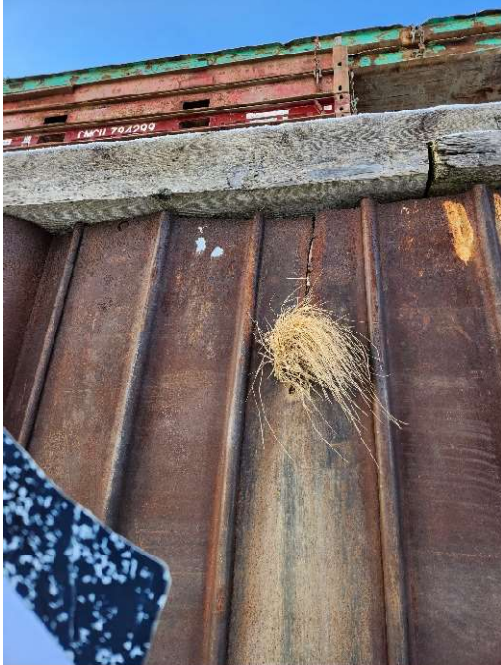
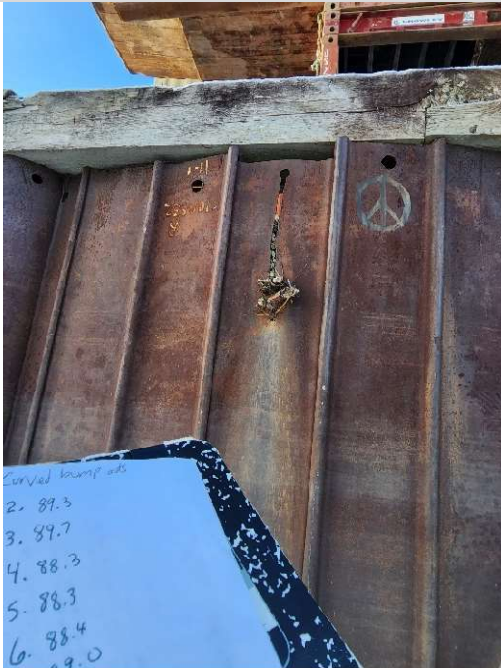
The sheet pile web cracks between soldier piles S11 and S13 may indicate over-stressing of the sheet piles due to failures in the anchoring system and demands exceeding the structural capacity.

Damaged sheet pile near soldier pile S11

Damaged sheet pile near soldier pile S12

Damaged sheet pile near soldier pile S13

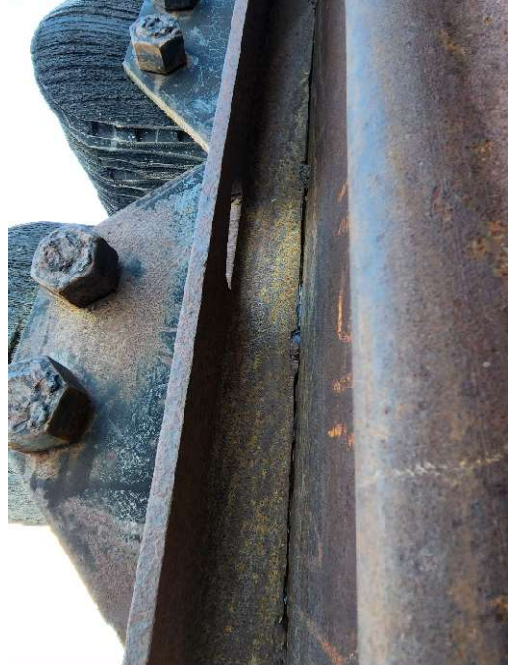
- The top rows of fendering are mounted to the scalloped shaped wall using welded WTs with varying web lengths to provide a straight segment of fendering. The fendering brackets on the north end have crack indications along the length of the welded connection to the sheet pile web.

Crack indication at connection between fendering bracket and wall near start of east wall fendering

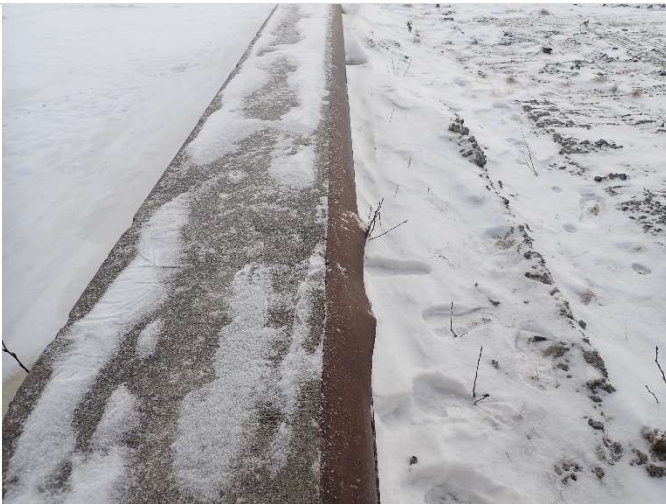
Minor damage to concrete curb metal strip along east wall.

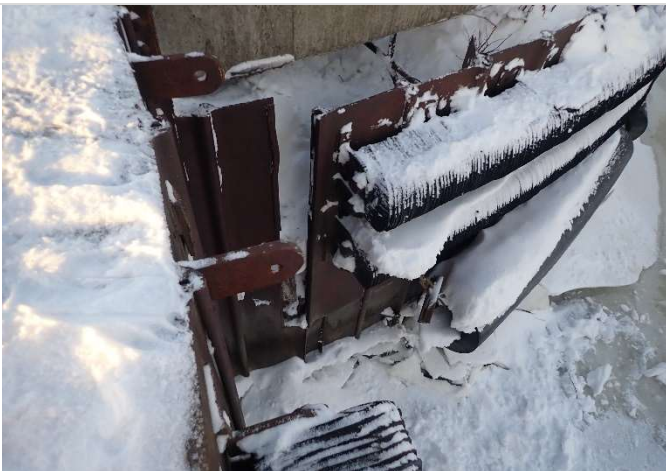
Fractured sheet pile with material loss at connection between east wing wall and dock closed sheet pile dock cell

Fractured sheet pile with material loss at east wing wall

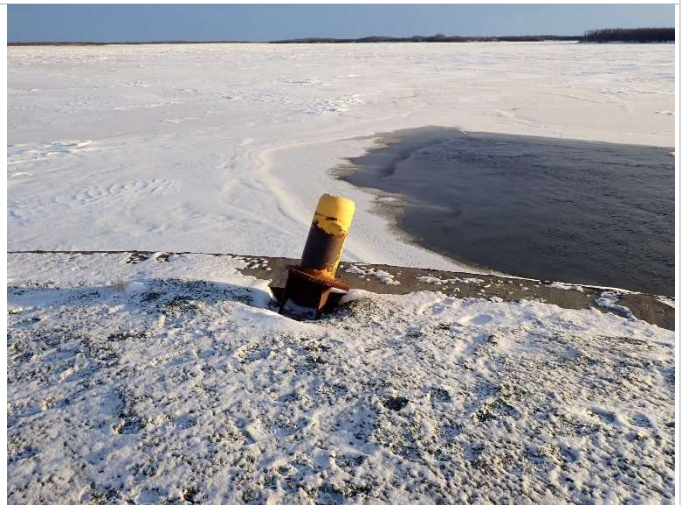
- A 10" diameter mooring bollard mounted on a HP pile is damaged and appears to have been overloaded.
- Two of the four 24" diameter pipe-pile mooring bollards are damaged.

Damaged 10" dia bollard at SE corner of dock (closed cell #1)

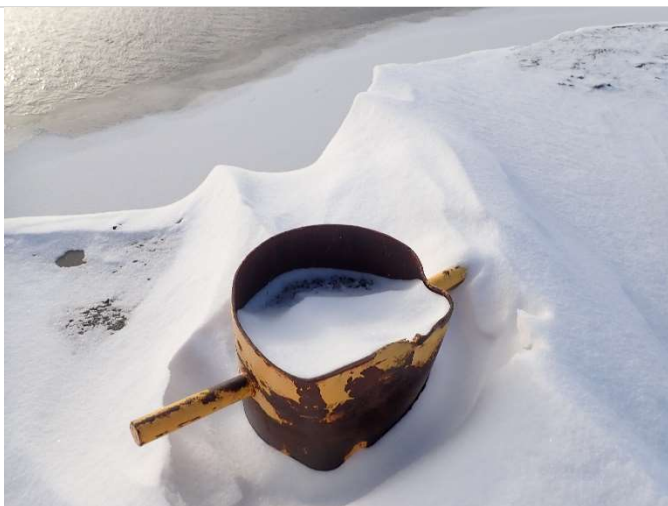
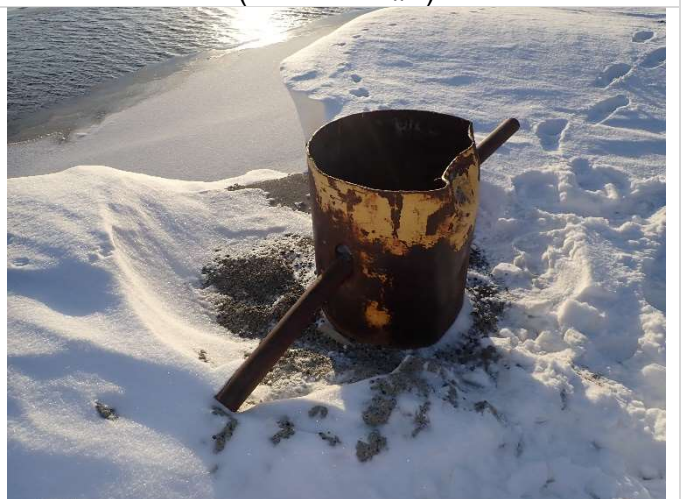
Damaged 24" dia pipe pile bollard at closed cell #2

Damaged 24" dia pipe pile bollard at closed cell #3. Hole has been drilled through pile-pile with a 3" dia bar inserted through the pile

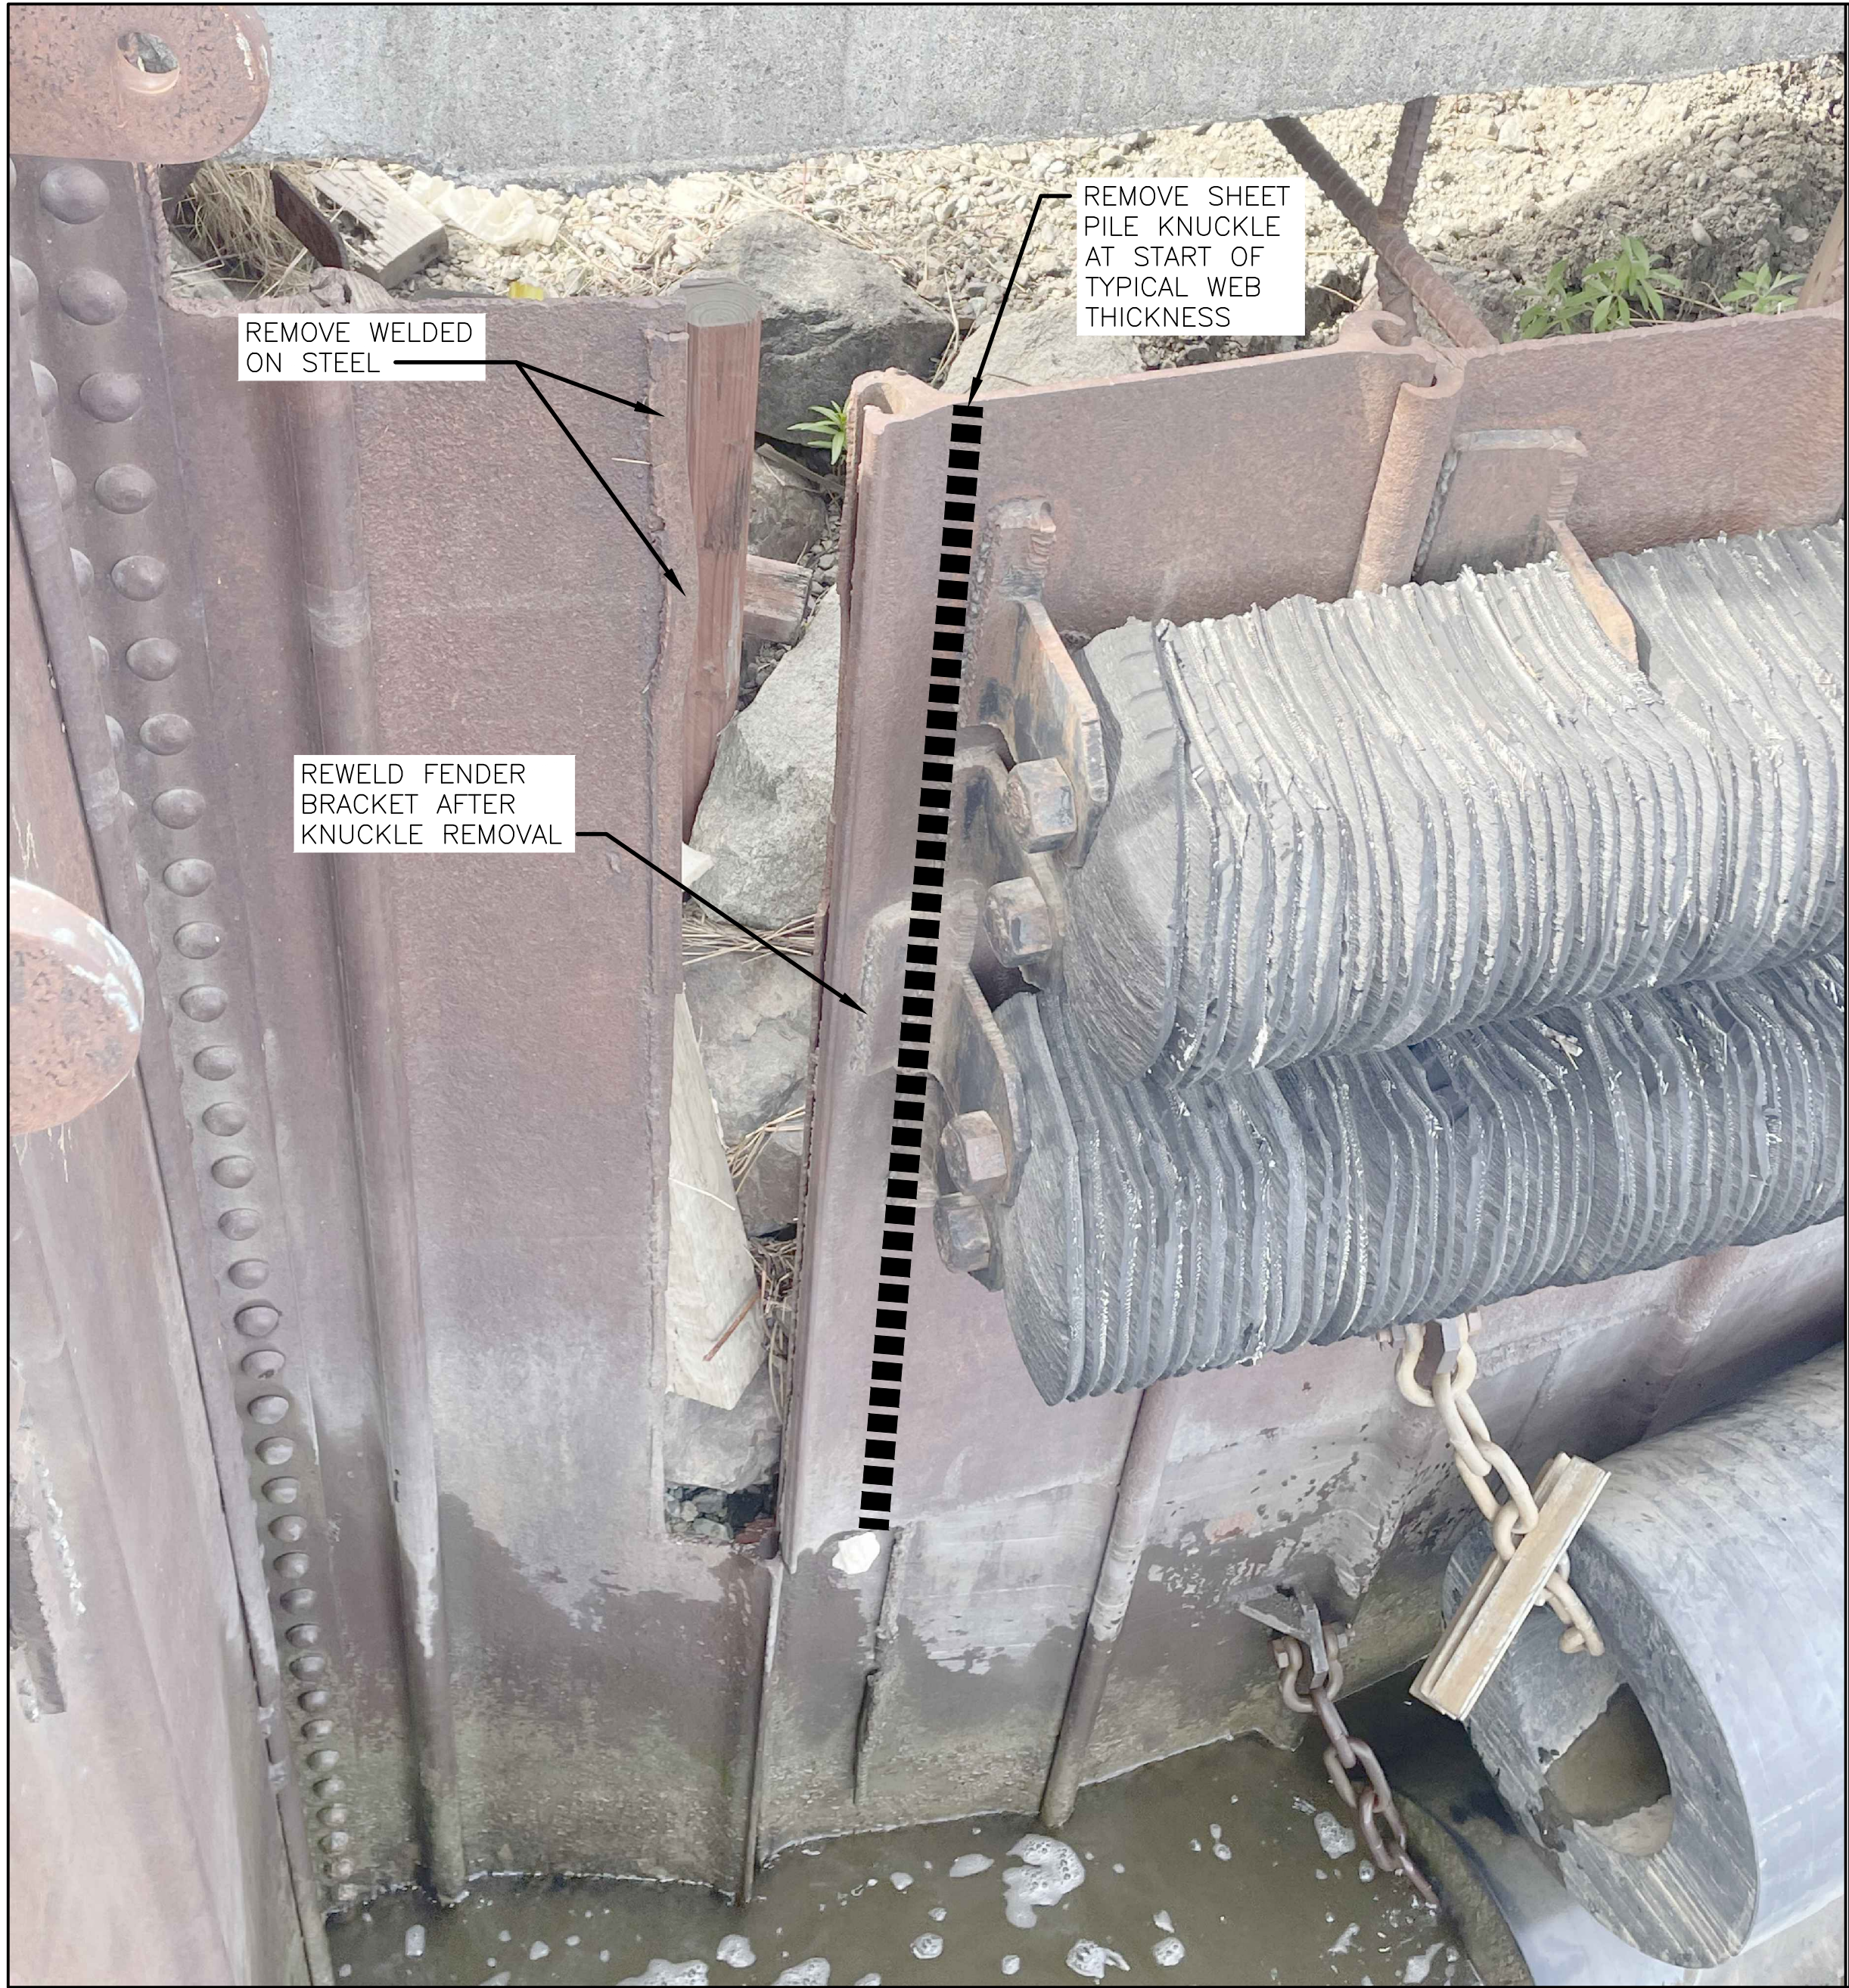
**SHEET PILE REPAIR SEQUENCE**

1. EXCAVATE BACKFILL AS REQUIRED FOR ACCESS.
2. REMOVE WELDED ON STEEL FROM NARROW SHEET PILE SECTION, SEE VIEW A-A.
3. REMOVE KNUCKLE FROM FULL SHEET PILE SECTION. REWELD FENDER BRACKET. SEE VIEW A-A.
4. PLACE NEW STEEL REPAIR PLATE BEHIND (FILL SIDE) OF SHEET PILE SECTIONS. SEE SHT. S0.02.
5. CLAMP REPAIR PLATE TO SHEET PILE SECTIONS TO TIGHT FIT.
6. DRILL BOLT HOLES THROUGH REPAIR PLATE AND SHEET PILE SECTIONS. SEE SHT. S0.02.
7. INSTALL AND TIGHTEN BOLTS.
8. BACKFILL EXCAVATION WITH CLEAN AGGREGATE.
